**Report ID:**  
17035

### **SCOPE OF INSPECTION**

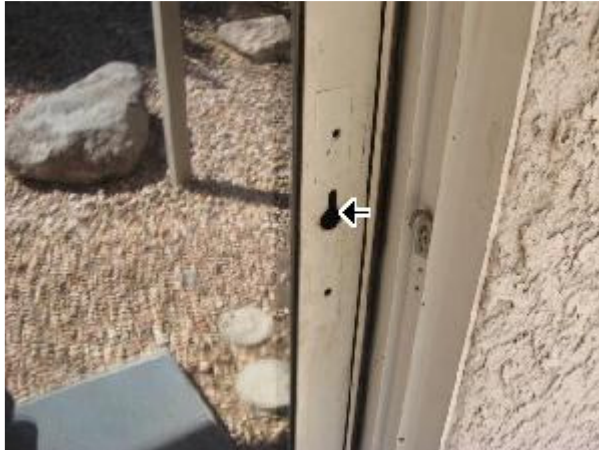
Picture 1

The door handle was missing to the rear yard patio door.

The door handle was missing to the rear yard patio door.

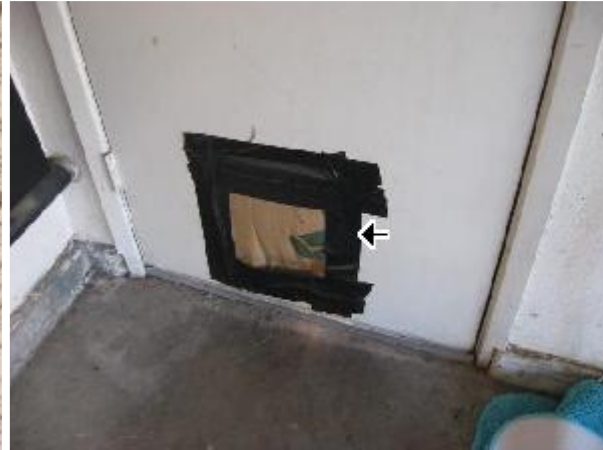
Picture 2

There was an opening in the garage to the side yard pass through door.

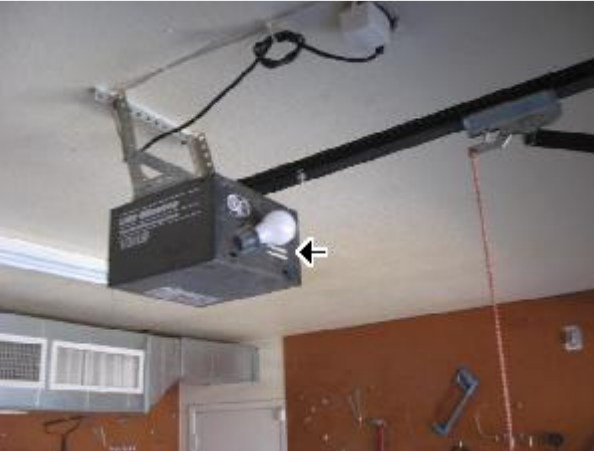
Seller stated that the garage door opener worked intermittently, so it was not tested.

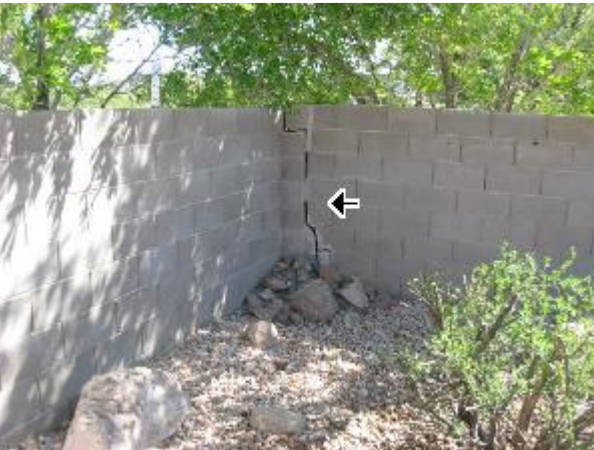
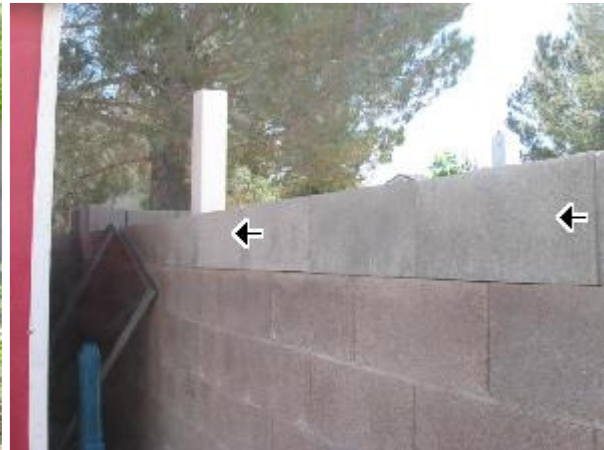
There was some damaged block wall observed at rear yard.

There were also bricks laid in place for privacy but were not grouted at the South side of the rear yard.

There was some damaged block wall observed at rear yard.

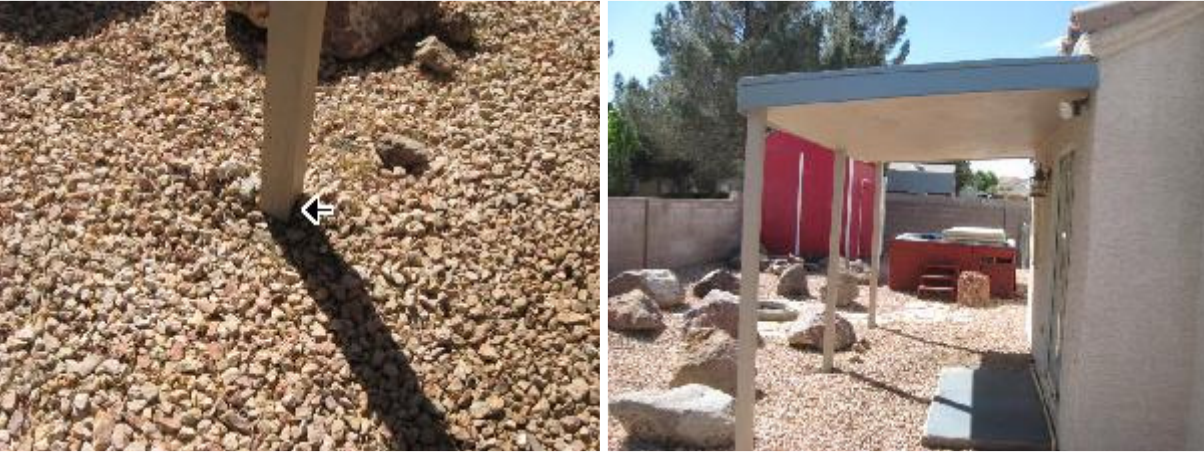
**Comments:** Inspected, Repair or Replace  
The rear yard patio cover did not appear to be professionally built, there was also earth to wood contact from the support poles.

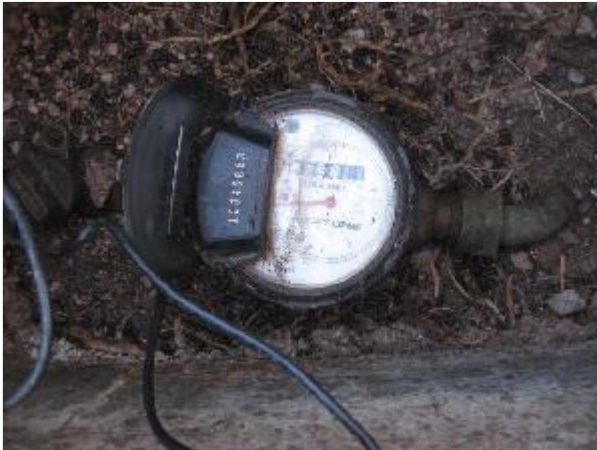
**Comments:** Inspected  
View

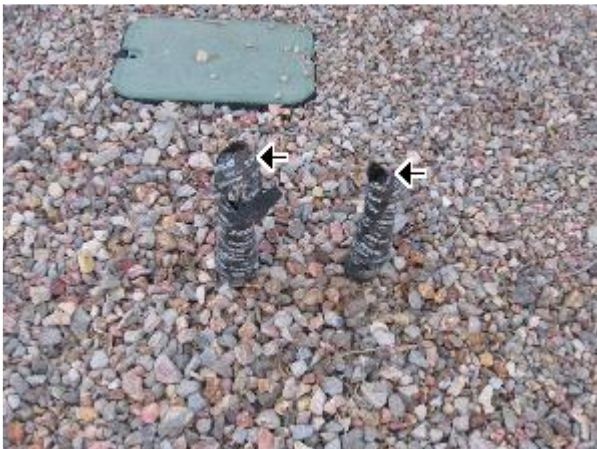
**Comments:** Inspected, Repair or Replace  
The anti-siphon valve was missing to the front yard sprinkler system.

- 4.1 **ANTI-SIPHON VALVES ( For lawn sprinklers or pool fill ).**  
**Inspected, Repair or Replace**  
 The anti-siphon valve was missing to the front yard sprinkler system.

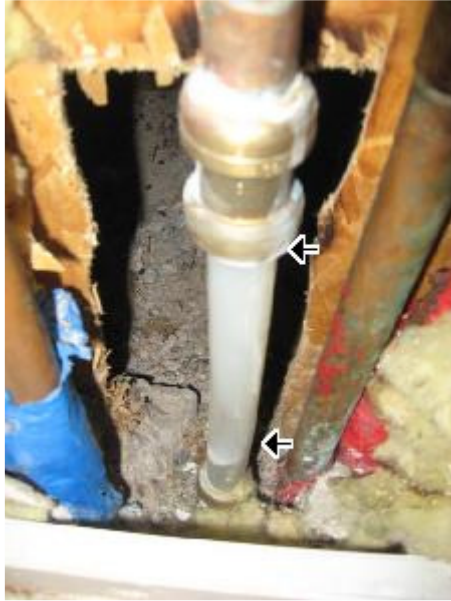
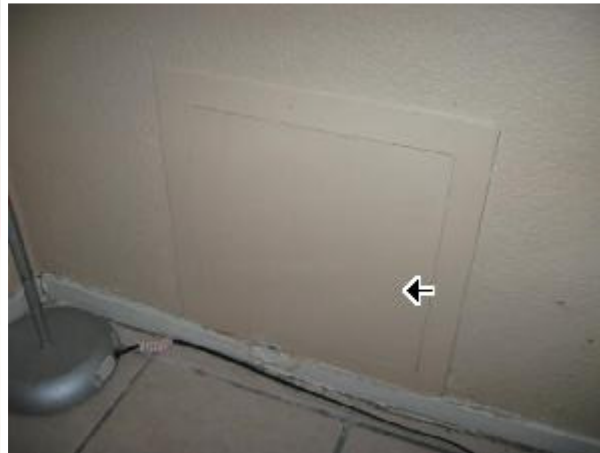
**Comments:** Inspected  
There was a past repair in the main water supply observed at the back side of the water heater pedestal from the bedroom/den side of an access panel.

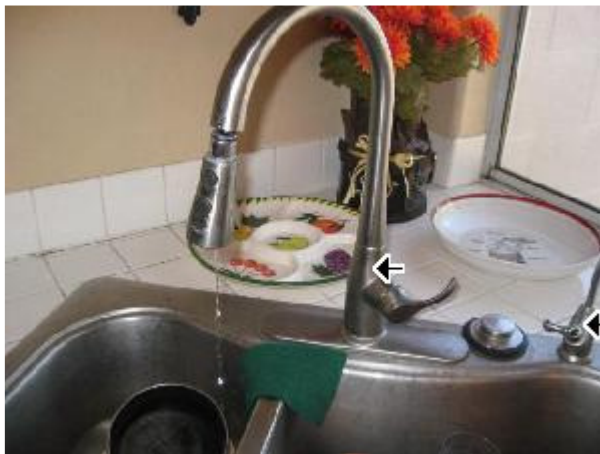
**Comments:** Inspected, Repair or Replace  
The filtered water spigot had very little to no water flow.  
There was no cold water to the kitchen faucet.  
There was modified plumbing under the kitchen sink to support the drainage pipes. (a wooden

stick)

**Inspected, Repair or Replace**  
 The filtered water spigot had very little to no water flow.  
 There was no cold water to the kitchen faucet.  
 There was modified plumbing under the kitchen sink to support the drainage pipes. (a wooden stick)

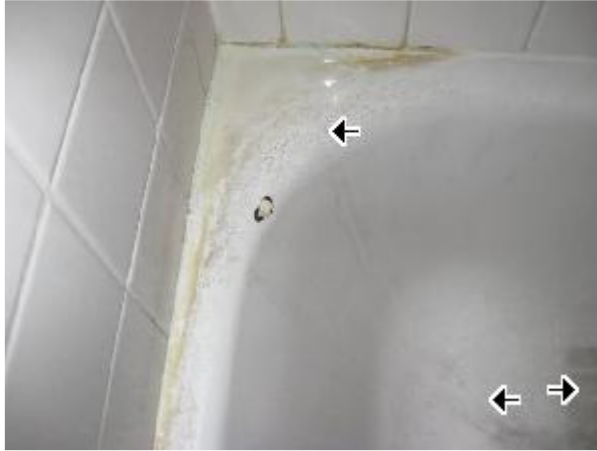
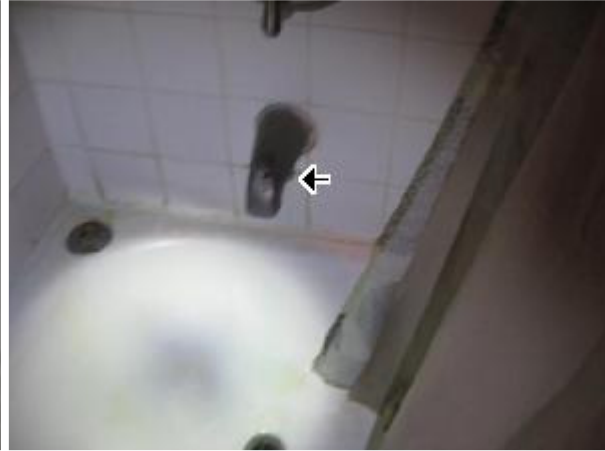
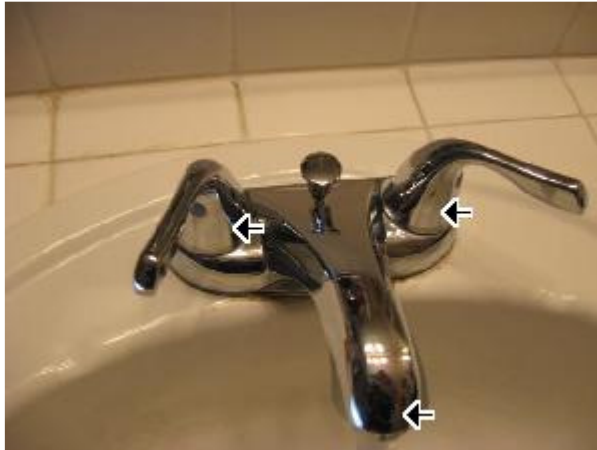
The tub valve has a constant drip and the bath tub is very worn and has small chips / nicks in the porcelain that is almost no longer existent.

The sink faucet has a drip and the handle are tight to turn on and off.

- 4.6 **HALL BATHROOM COMPONENTS**  
**Inspected, Repair or Replace**  
 The tub valve has a constant drip and the bath tub is very worn and has small chips / nicks in the porcelain that is almost no longer existent.  
 The sink faucet has a drip and the handle are tight to turn on and off.

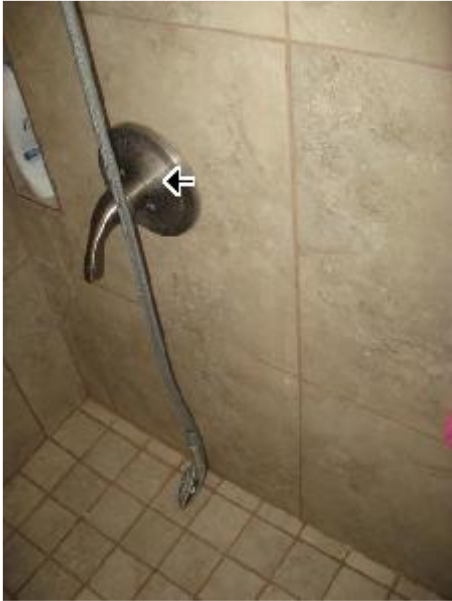
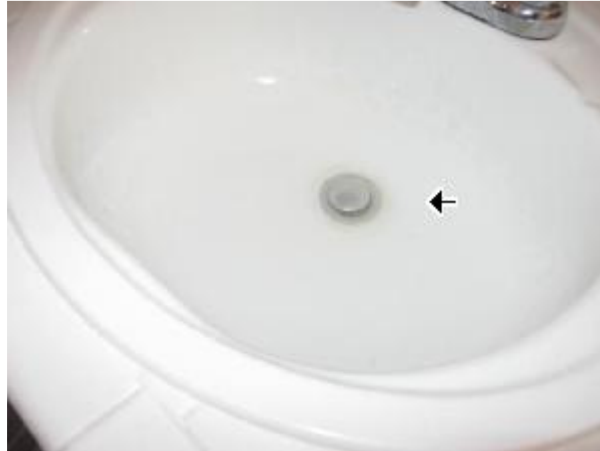
**Comments:** Inspected, Repair or Replace  
Hot and cold are reversed in the shower location.  
Left side sink was slow draining.

- 4.7 **MASTER BATHROOM**  
**Inspected, Repair or Replace**  
 Hot and cold are reversed in the shower location.  
 Left side sink was slow draining.

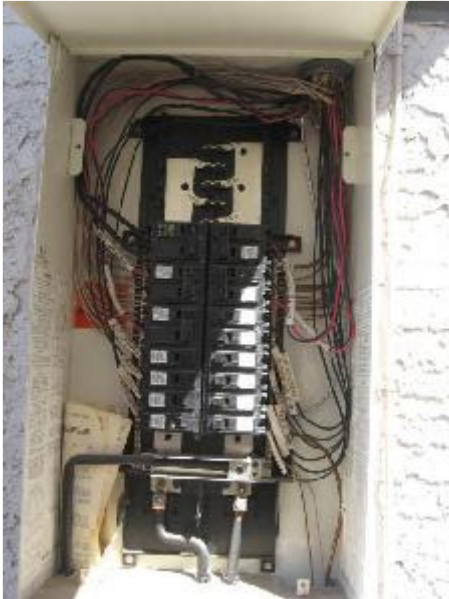
The main electrical distribution panel is located on the exterior wall - information only.

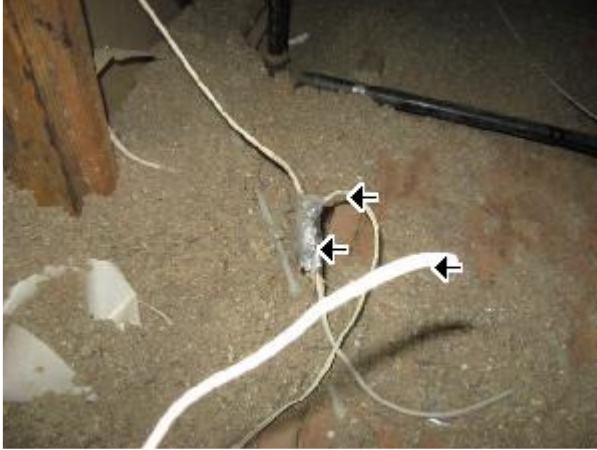
There is an improper wire splice in attic that has a live wire that is not connected to anything. This is a live wire and needs to be addressed for safety.

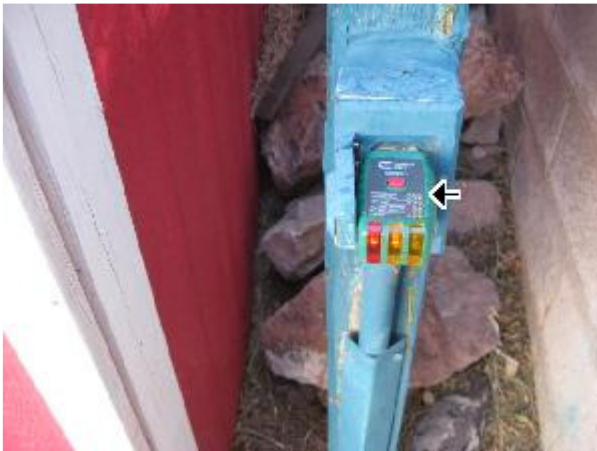
Outlet at rear yard next to the shed is wired improperly.

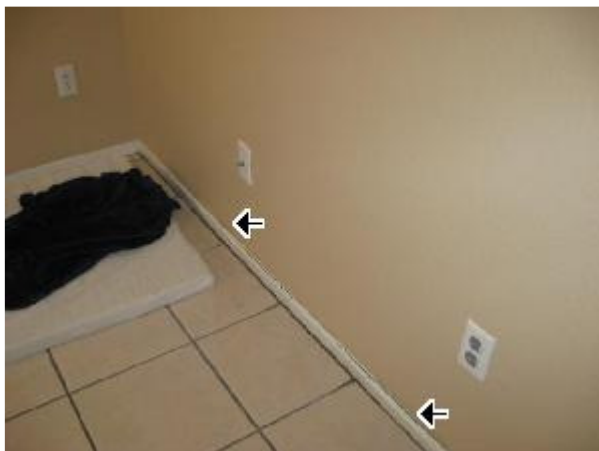
There were swollen baseboards observed at the bedroom adjacent to the laundry room.  
The seller stated that the washiness machine overflowed in the past.

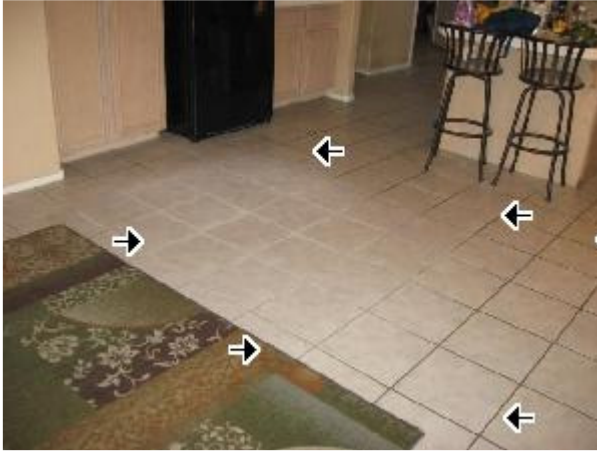
There was a large area of loose and lifting and broken floor tiles in the kitchen dining family location.

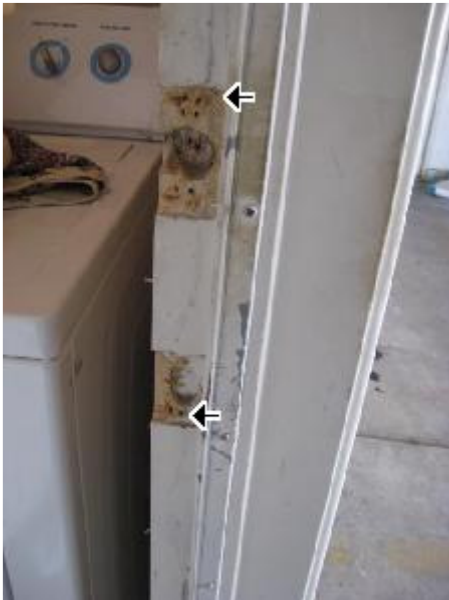
The door jamb from the garage to the house in the laundry room is damaged.  
The master bathroom toilet room door does not properly latch.

The door jamb from the garage to the house in the laundry room is damaged.  
The master bathroom toilet room door does not properly latch.

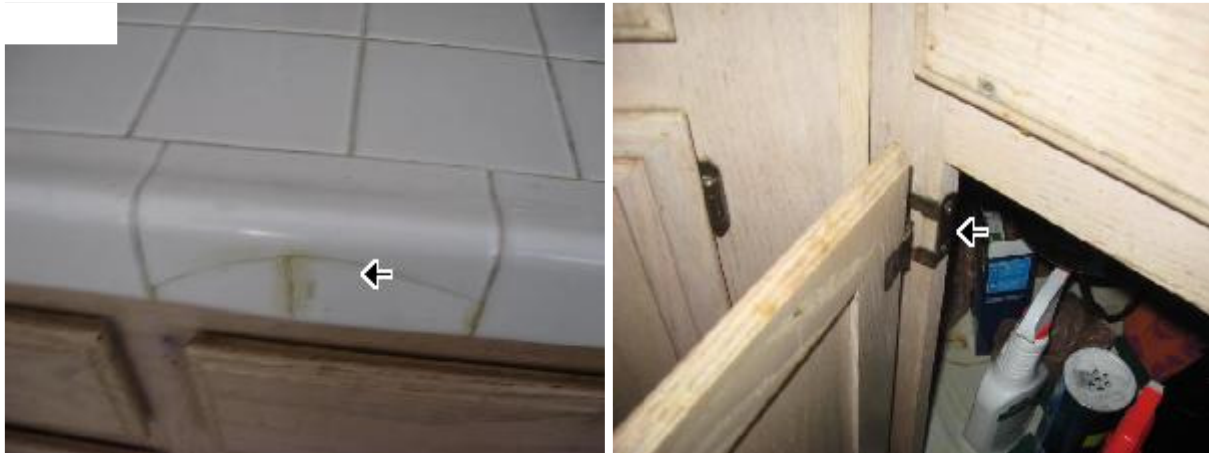
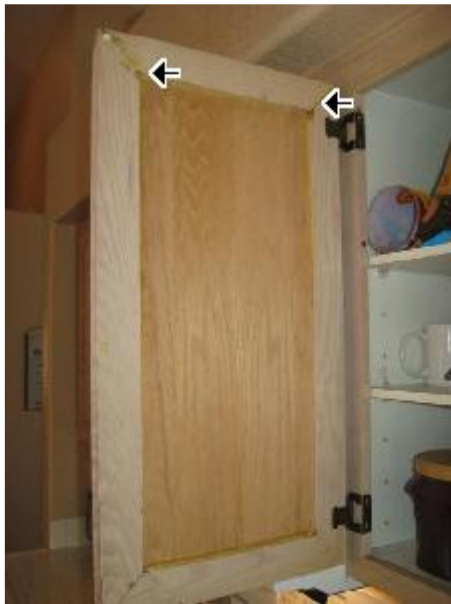
**Comments:** Inspected, Repair or Replace  
There were several cracked kitchen counter top tiles.  
There was a loose cabinet door hinge under the sink location.  
There was a damaged cabinet door that has been somewhat repaired.

There were several cracked kitchen counter top tiles.  
There was a loose cabinet door hinge under the sink location.  
There was a damaged cabinet door that has been somewhat repaired.

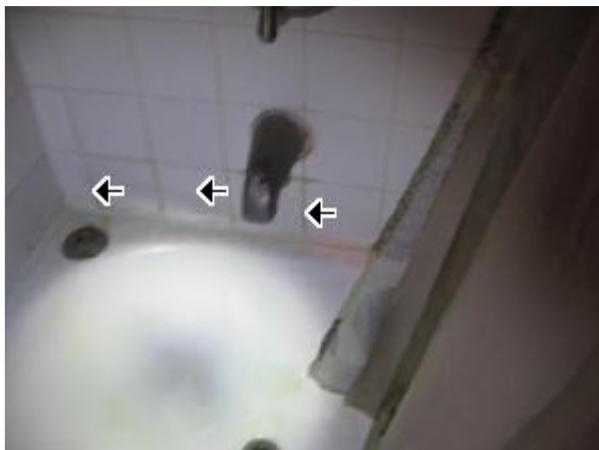
There were several loose wall tiles in the hall bath tub surround location, unable to determine the damage behind these loose wall tiles.

There was a broken medicine cabinet mirrored door.

There were several loose wall tiles in the hall bath tub surround location, unable to determine the damage behind these loose wall tiles.  
There was a broken medicine cabinet mirrored door.

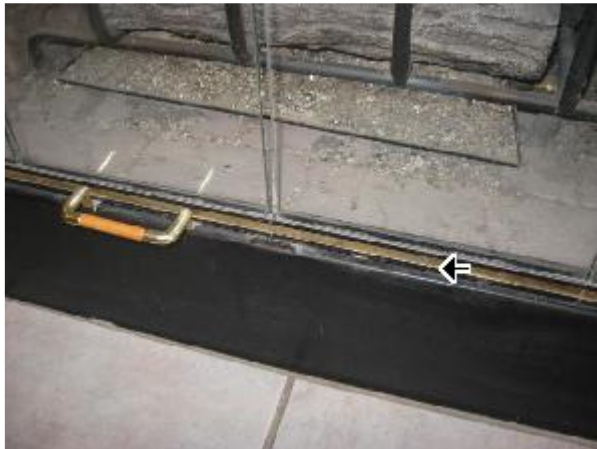
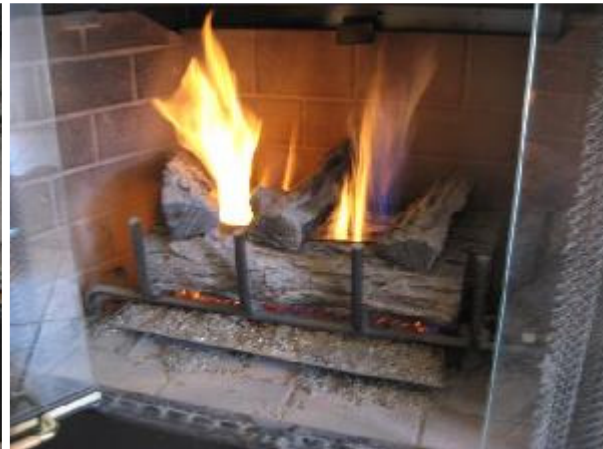
**Comments:** Inspected, Repair or Replace  
There was a missing handle for the glass doors of the fireplace.

There was a missing handle for the glass doors of the fireplace.

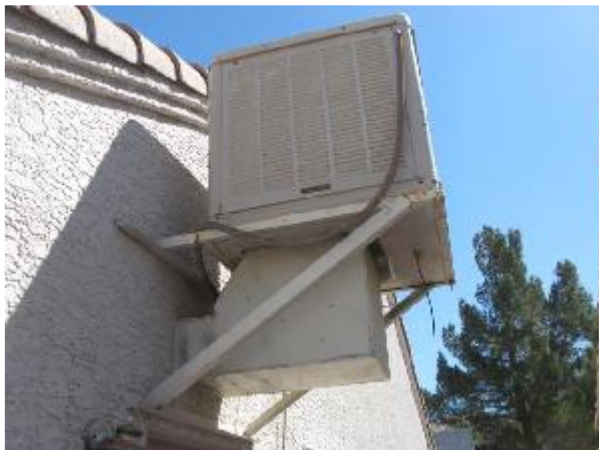
Evaporator coolers are not normally inspected, however I did attempt to turn the blower on to this unit and it did not come on at the wall switch FYI.

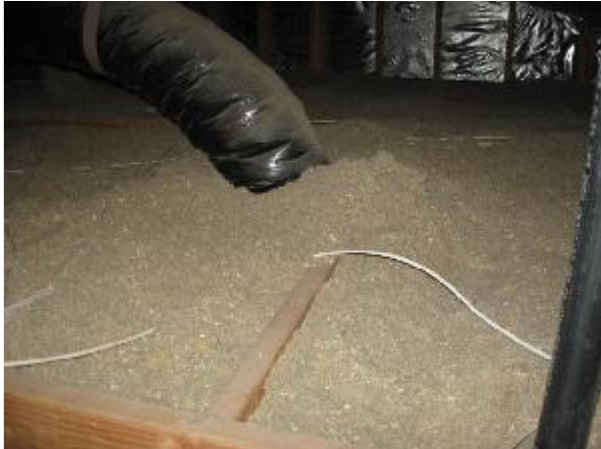
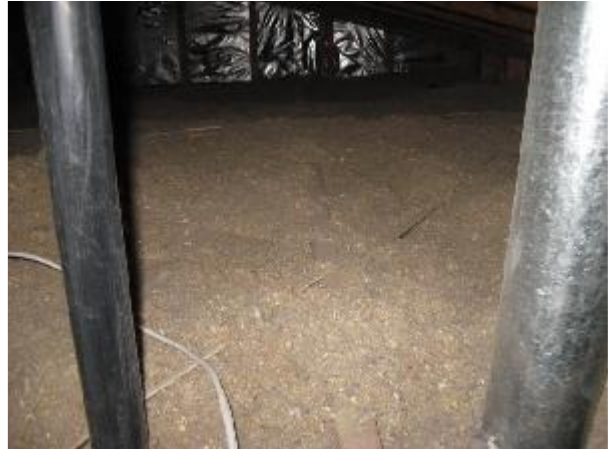
**Comments:** Inspected  
Views of attic insulation.
